STOPS FORMICARY CORROSION IN ITS TRACKS

Anteater® Coil Exhibits 50X the Formicary Corrosion Protection of Standard C12200 Copper

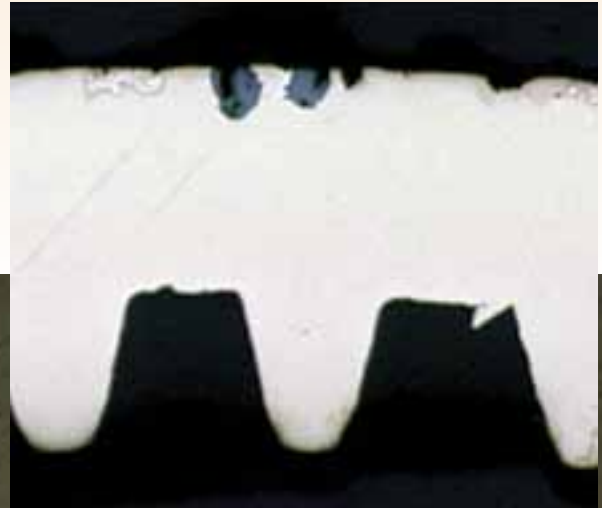
Anteater coil after 180 days of accelerated testing. Pitting stops; no formicary migration through tubing; no leak.

The Anteater coil is made with UNIGUARD™ copper alloy, which includes zinc additives to stop formicary corrosion from tunneling through the material. When acid begins to attack the coil copper, the Anteater alloy prevents the acid from tunneling completely through the copper grain. Some surface pitting will still be evident, but the damage will be stopped before it can cause a leak.

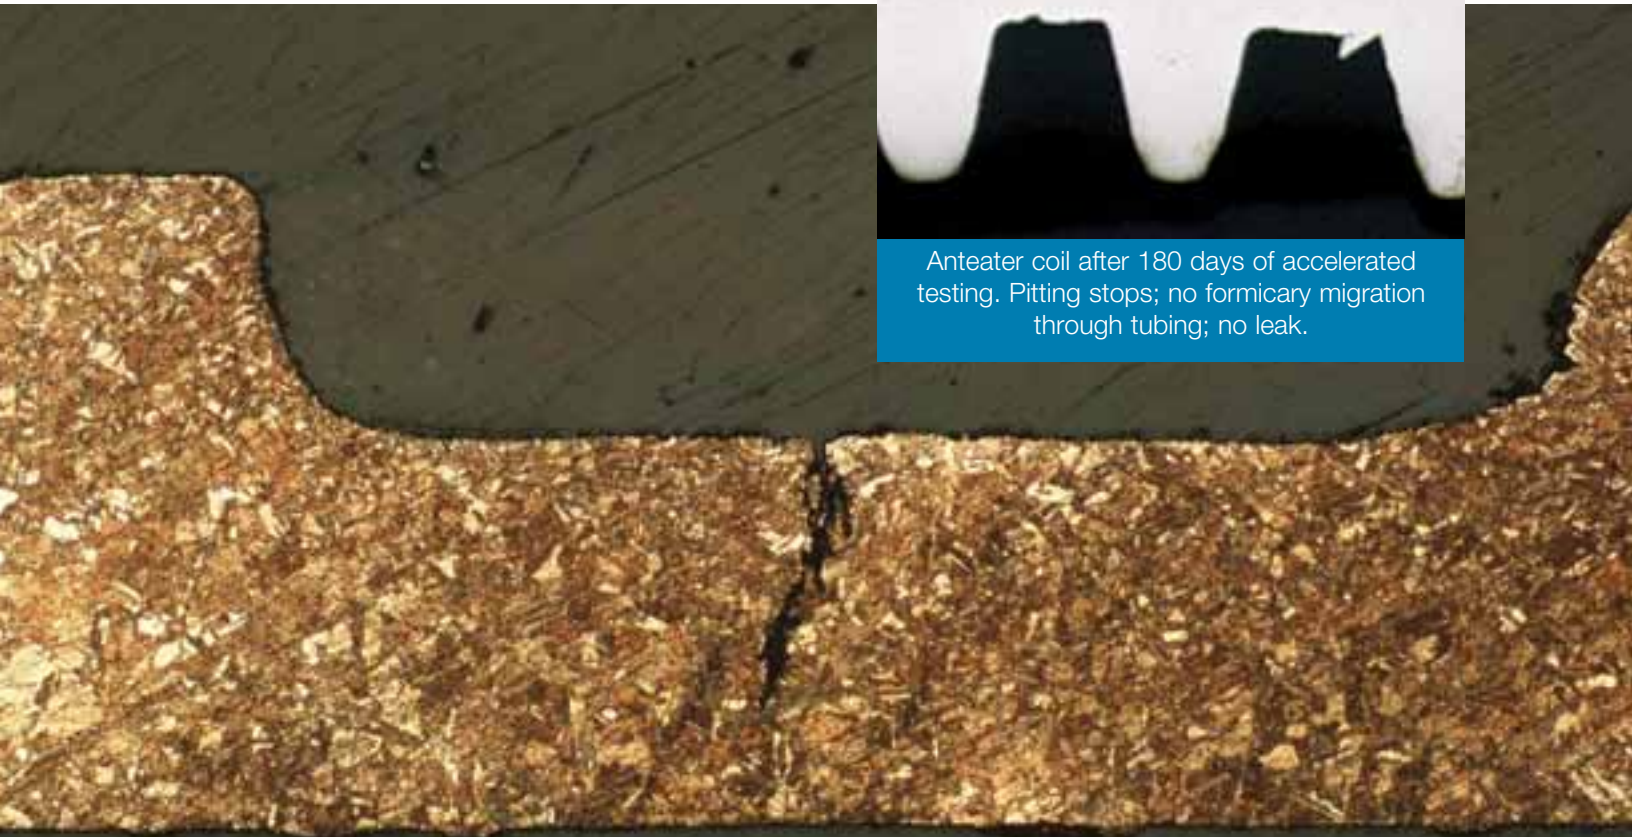
Traditional copper coil showing formicary corrosion. Field failure occurring just two months from manufacture date.

As the major cause of indoor coil leaks, formicary corrosion occurs in copper-based alloys and is comprised of small, wandering pits that are not observable to the unaided eye. The tunneling effect that occurs to the copper material is similar to tunnels formed in an ant's nest. "Formicary" literally means "ant's nest."

Acid – Environmental contaminants such as household particles collect on the copper tubing and mix with the moisture. This forms an organic acid that begins to eat away at the copper. The acid creates a tunneling effect similar to that of ant tunnels, penetrating the copper completely and creating the leak.
